2023 Update

Lotus Lake

Lotus Lake Water Quality by the Numbers

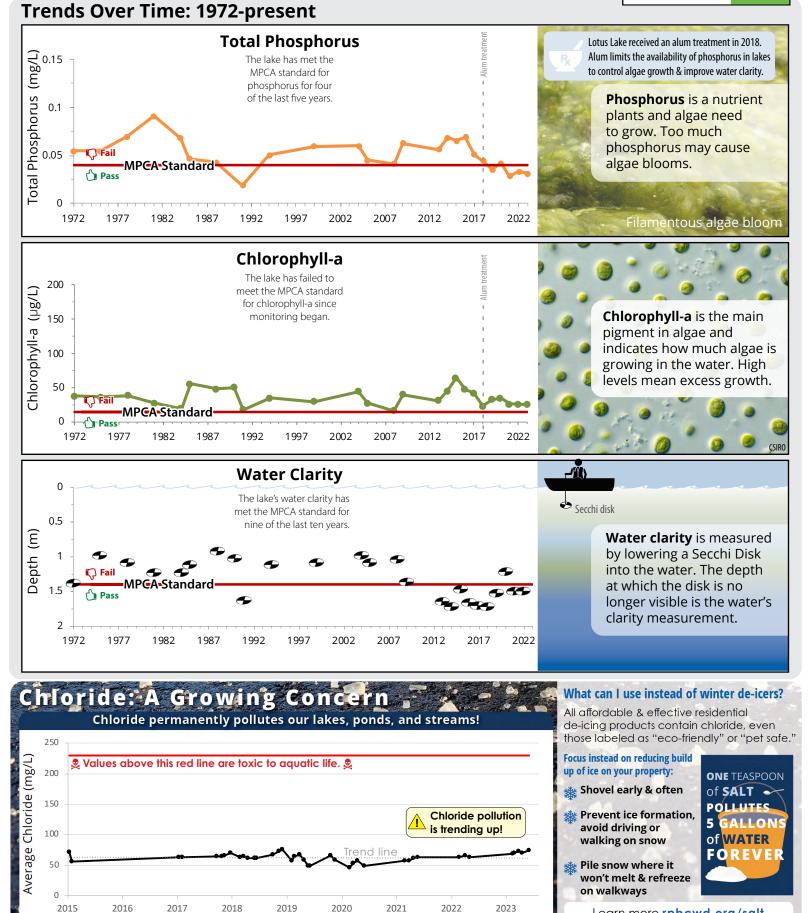
For the last few years, **Lotus Lake** has consistently met the clean water standards set by the MPCA, except for Chlorophyll-a. The graphs below show water quality trends over time with the red line representing the MPCA standard for **deep lakes**.

Total Phosphorus: Since the alum treatment in 2018, the lake has consistently met the MPCA standard (<0.04 mg/L) In 2023, the average level was 0.031 mg/L.

Chlorophyll-a: The lake has never met the MPCA standard (<14 µg/L). In 2023, the average chlorophyll-a reading was 24.6 µg/L.

Water clarity: Since 2013, the lake has consistently met the MPCA standard (>1.4 meters) for water clarity except for one year. The average reading in 2023 was 2.0 meters.
