Lake Lucy

Lake Lucy Water Quality by the Numbers

Trends Over Time: 1972-present

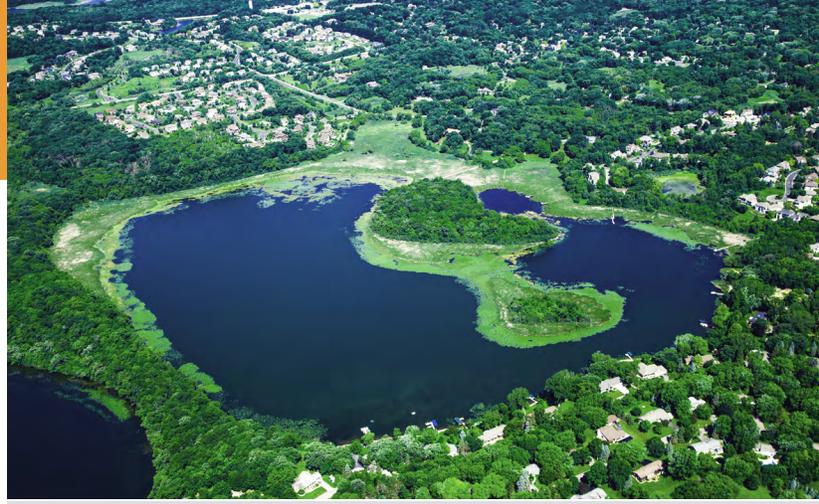
Watershed Boundary

Lake Lucy is the headwaters to Riley Creek. Water flows out of Lucy to Lake Ann and then to Riley Creek. On its way south to the Minnesota River, Riley Creek passes through Susan, Rice Marsh, and Riley lakes.

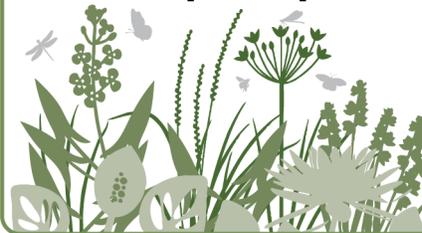
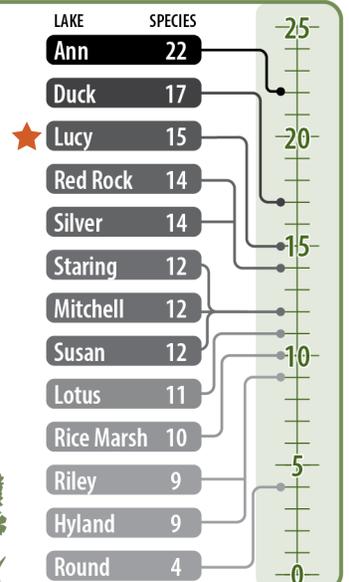
Native Aquatic Plant Diversity

How does **Lake Lucy** compare to **other lakes** in the District in **number of native plant species?**

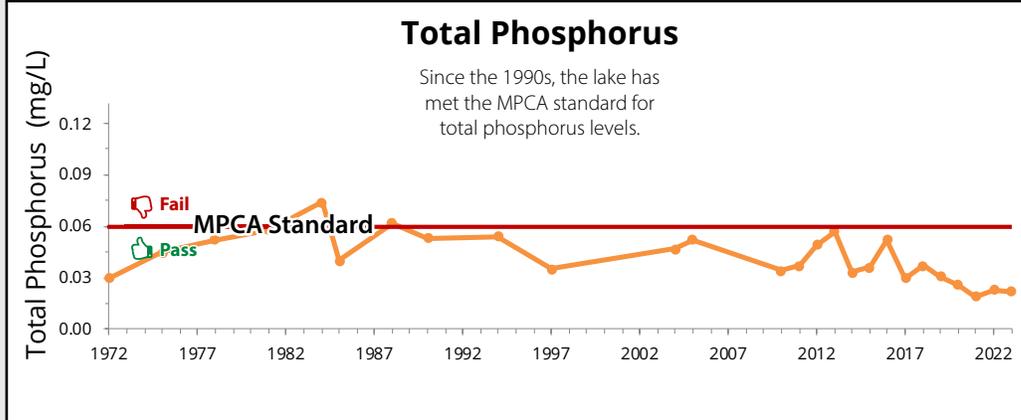
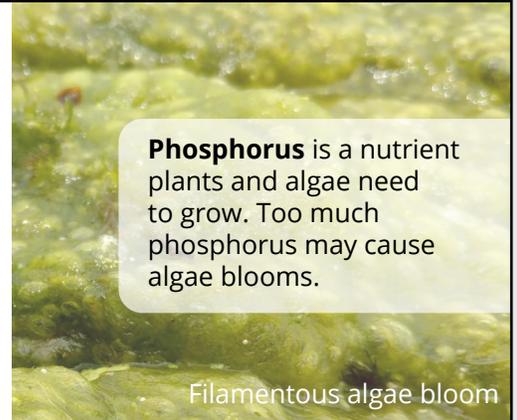
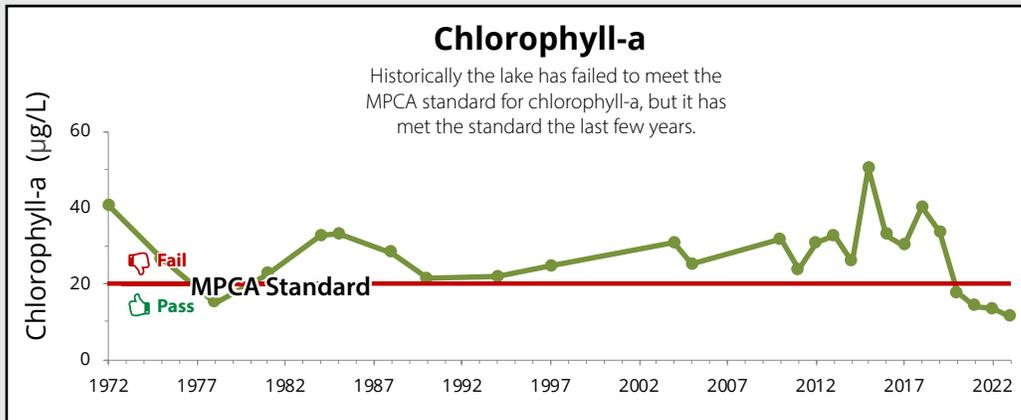
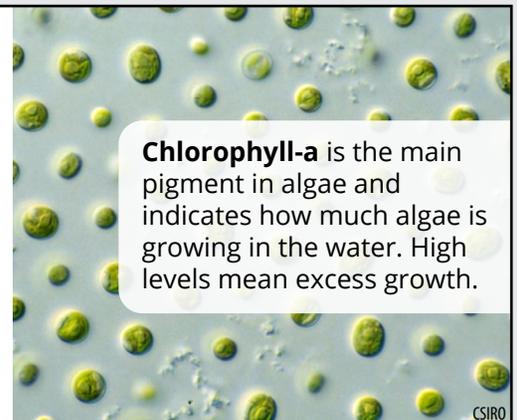
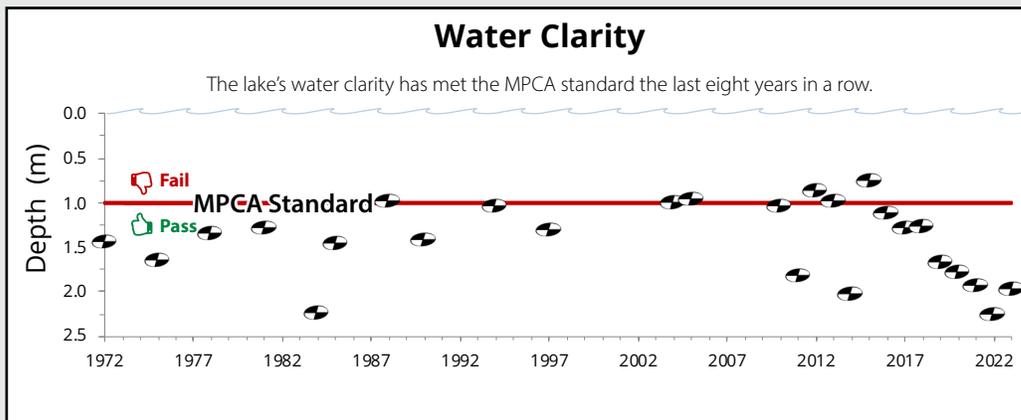
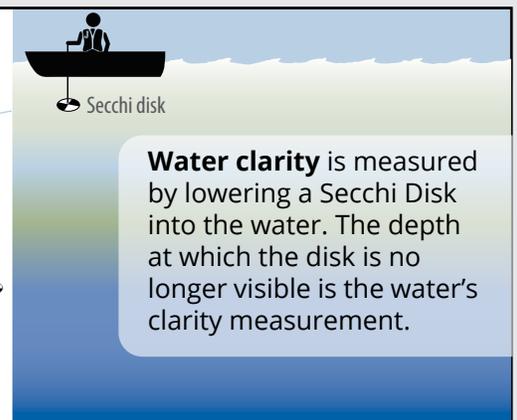
P **Total Phosphorus:** No significant trend since monitoring began. In 2023, the lake met the MPCA shallow lake standard (<0.06 mg/L) with average level of **0.028 mg/L**.

Chlorophyll-a: Levels have declined the last few years, which is likely linked to a winterkill events in 2018/2019 and 2022/2023. In 2023, the average reading for chlorophyll-a was **11.3 µg/L**, well within the MPCA standard (<20 µg/L).

Water clarity: Lake clarity has improved since 2019, and the lake consistently meets the MPCA standard (>1.0 meters). The average reading in 2023 was **2.0 meters**.

Over the last few years, **Lake Lucy** has met the clean water standards set by the MPCA. The graphs below show water quality trends over time with the red line representing the MPCA standard for shallow lakes.
